# THE IMPACT RESISTANCE OF CURRENT DESIGN COMPOSITE FAN BLADES TESTED UNDER SHORT-HAUL OPERATING CONDITIONS

## INTERIM REPORT

GENERAL ELECTRIC COMPANY  
Advanced Engineering and Technology  
Programs Department

1. Report No. NASA CR-134533	2. Government Accession No.	3. Recipient's Catalog No.	
4. Title and Subtitle "Impact Resistance of Current Design Composite Fan Blades Tested Under Short-Haul Operating Conditions"		5. Report Date July 1973

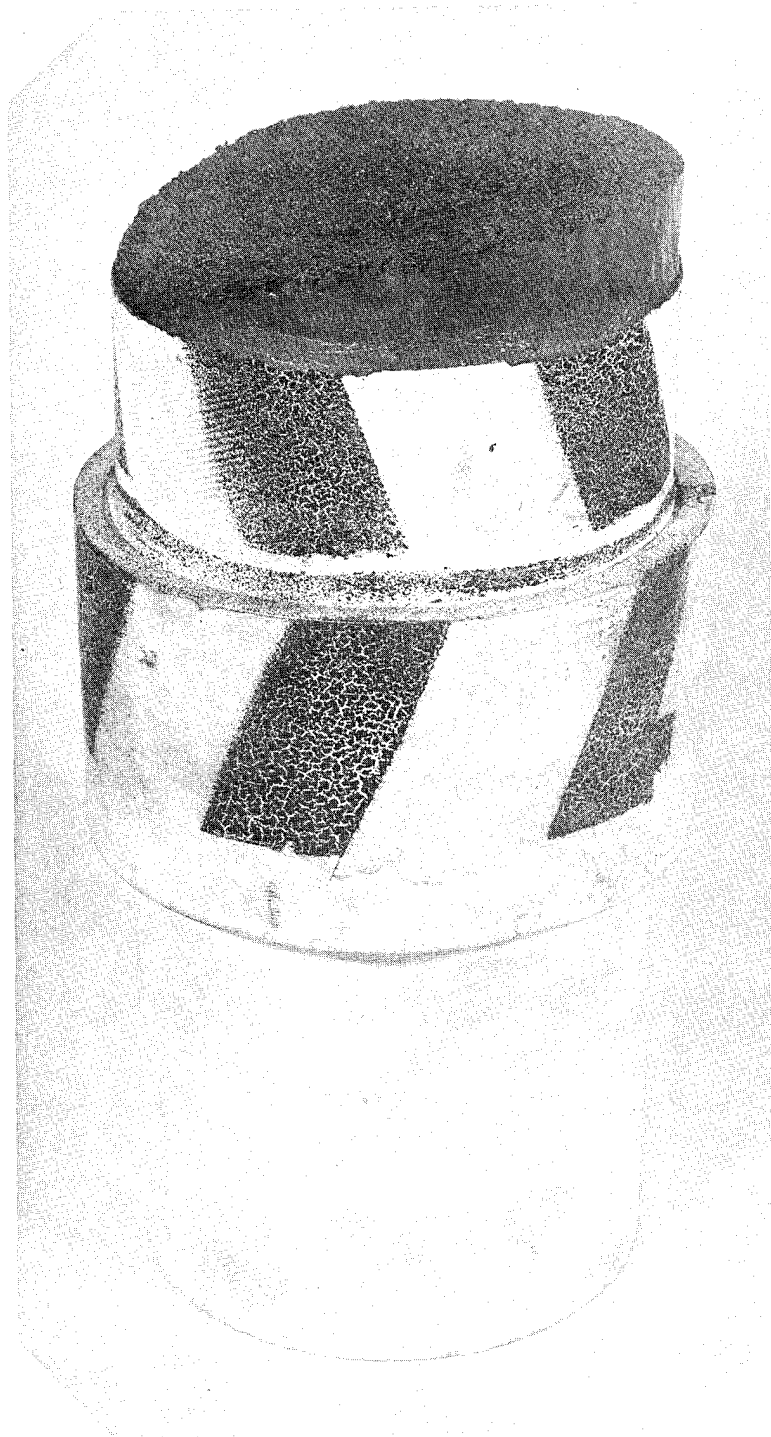
Figure 3. Photograph Showing Containment of Simulated (RTV) Bird After Impact, 12 oz Slice Removed.

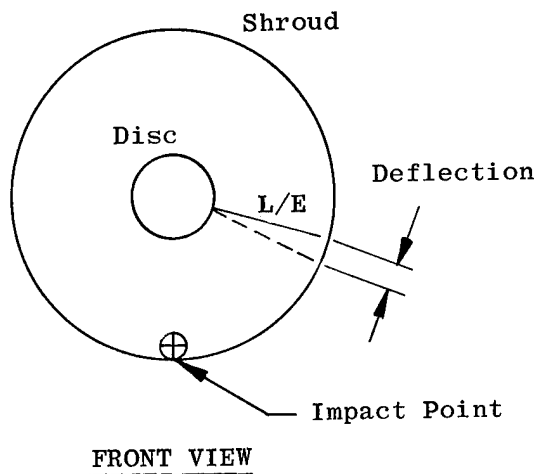
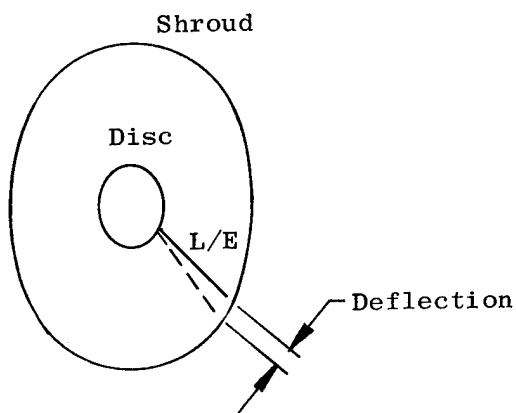
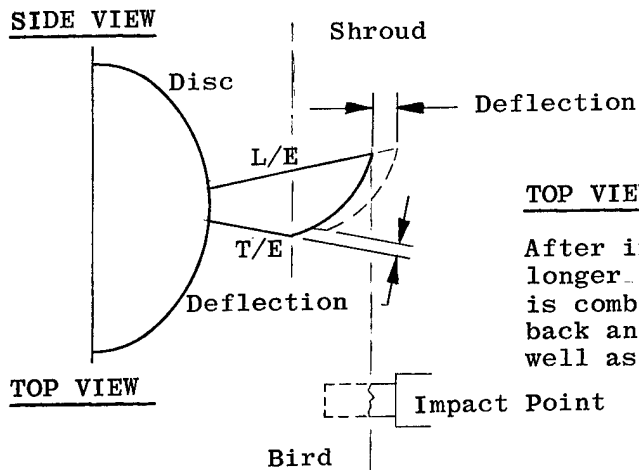
Front and side views show position of blade leading edge before and after impact typical for 5 and 3 o'clock positions.

Deflections are a combination of bending and twisting.

After impact blade appears longer and narrower. Deflection is combination of blade bending back and axially forward as well as untwisting.

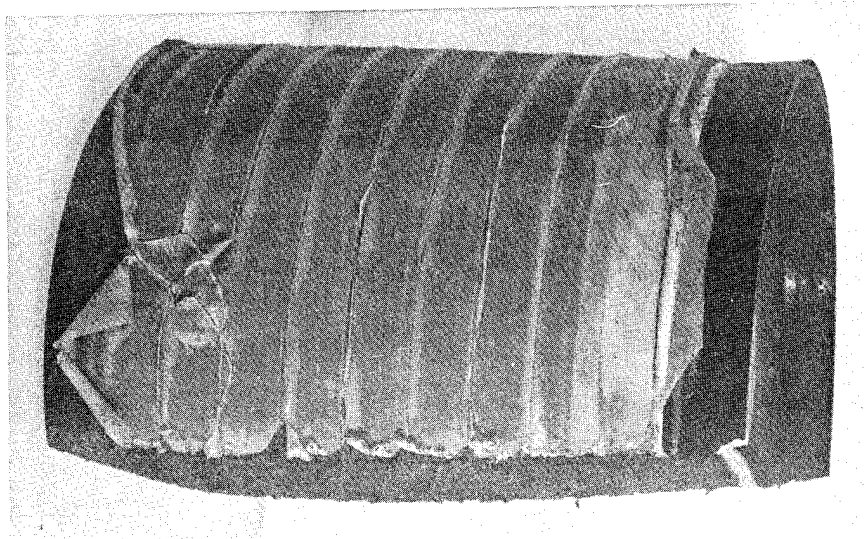
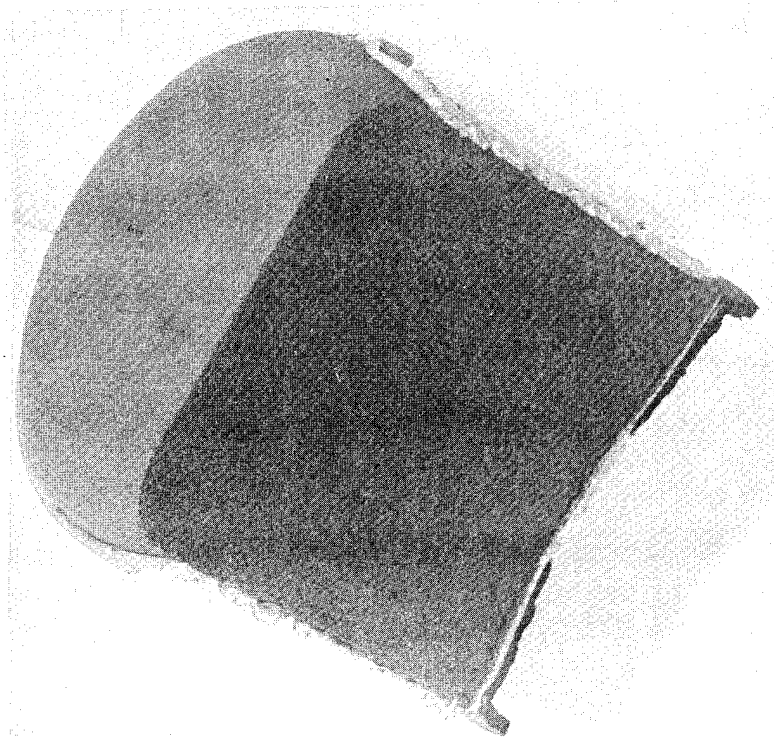
These facts have been greatly clarified during the present program by the recovery of projectiles after impact. A typical projectile recovered after testing is shown in Figure 15. The sliced plane is clearly shown as the dark region extending from the front of the projectiles, and tapering into the projectile toward the rear. The sharp intersection of the slice-plane with the front surface of the projectile shows the initial projectile "bite" that is set up as an initial test condition.

Figure 15. Typical RTV Recovered Projectile after Inertial Head Impacting of Composite Blades.
